Left Side Cover

Removal -

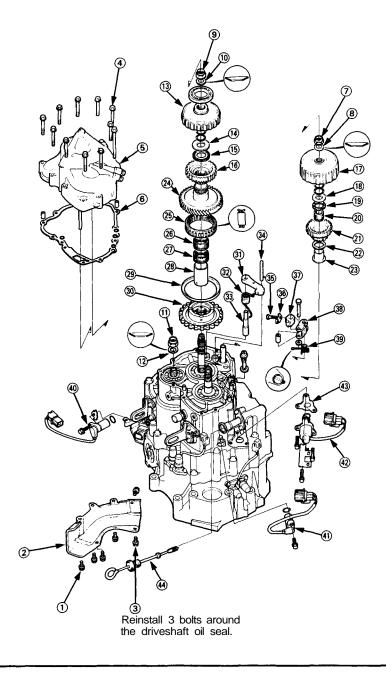
NOTE: Using a chisel, cut the lock tab. Pry it up and then remove the locknut from each shaft.

CAUTION: Keep all of the chiseled particles out of the transmission.

CHISEL

LOCK TAB
